Sundance Home Inspections

Property Inspection Report

Property address: **19 Neighbors Way
Your Town, USA 00000**

Inspection date: **6/2/2012**

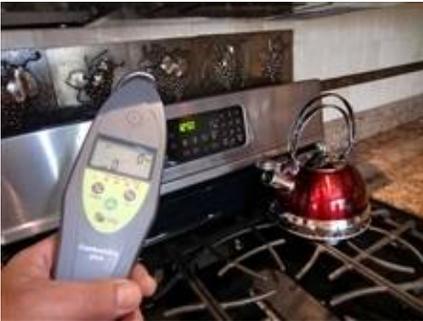
Photo 35

1) *Safety, Repair/Replace, Evaluate* - One or more leaks were found in gas supply lines, fittings, valves and/or back spillage from heating equipment. This is a safety hazard due to the risk of explosion and/or carbon monoxide exposure. A qualified contractor and/or the gas utility company should evaluate and make repairs as soon as possible.

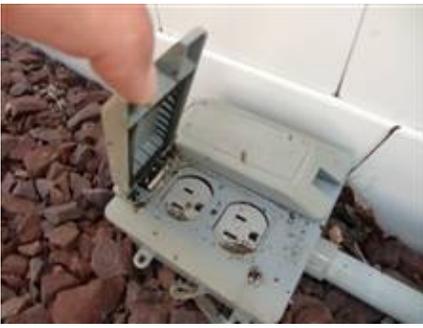
Photo 72

3) *Infestation, Damage* - Indications of insect intrusion was noticed at exterior electrical receptacles. Recommend having a licensed exterminator evaluate and make suggestions on remediation's and/or repairs that are needed.

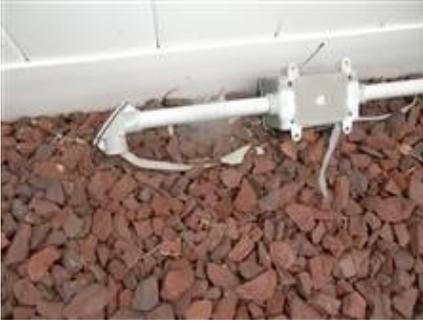
Photo 7

4) *Safety, Repair/Replace, Evaluate* - One or more electric receptacles and/or the boxes they are installed in are loose and/or not securely anchored. Wire conductors may be damaged due to repeated movement and/or tension on wires, or insulation may be damaged. This is a safety hazard due to the risk of shock and fire. A qualified electrician should evaluate and repair as necessary.

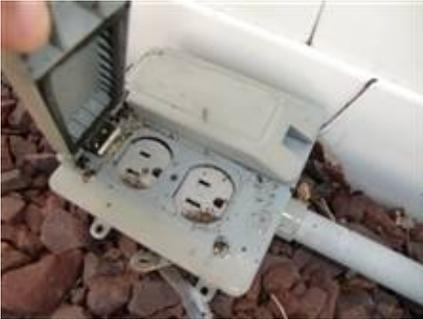
Photo 71

5) *Safety, Repair/Replace, Evaluate* - One or more outdoor electric receptacles appear to have no ground fault circuit interrupter (GFCI) protection. This is a safety hazard due to the risk of shock. A qualified electrician should evaluate to determine if GFCI protection exists, and if not, repairs should be made so that all outdoor receptacles within six feet six inches of ground level have GFCI protection. For example, install GFCI receptacles or circuit breaker(s) as needed.

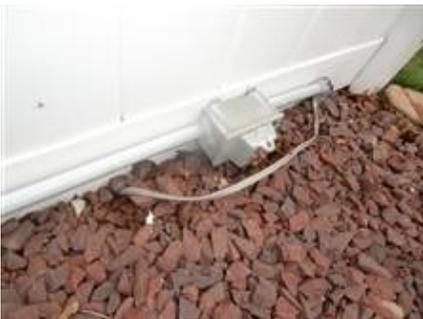
Photo 8

6) *Safety, Repair/Replace, Evaluate* - Non-metallic sheathed wiring is routed in one or more areas so it is subject to damage, such as on wall or ceiling surfaces. The insulation can be damaged by objects coming in contact with it and/or it being repeatedly moved. This is a safety hazard due to the risk of shock and fire. A qualified electrician should evaluate and repair as necessary. For example, rewire using conduit, or re-routing through wall cavities.

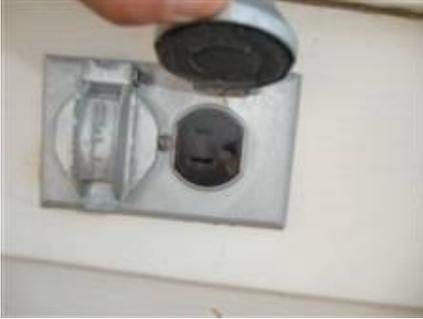
Photo 70

7) *Repair/Replace, Evaluate* - One or more electric receptacles appear to have no power. Recommend asking the property owner(s) about this. Switches may need to be operated to make some receptacles energized. If necessary, a qualified electrician should evaluate and make repairs as necessary.

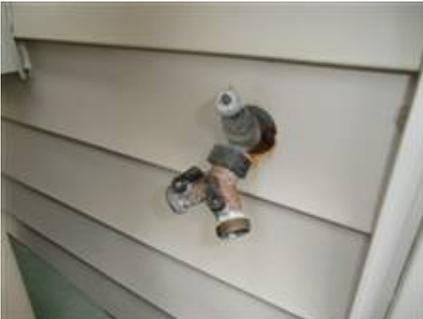
Photo 11

8) *Repair/Replace* - One or more outside faucets are missing handles. Recommend installing handles where missing.

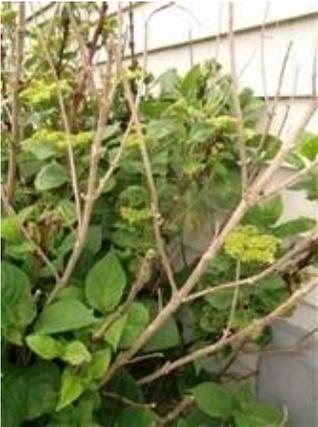
Photo 4

9) *Repair/Maintain, Conducive conditions* - Vegetation such as trees, shrubs and/or vines are in contact with or less than one foot from the structure's exterior. Vegetation can serve as a conduit for wood destroying insects and may retain moisture against the exterior after it rains. Vegetation should be pruned and/or removed as necessary to maintain a one foot clearance between it and the structure's exterior.

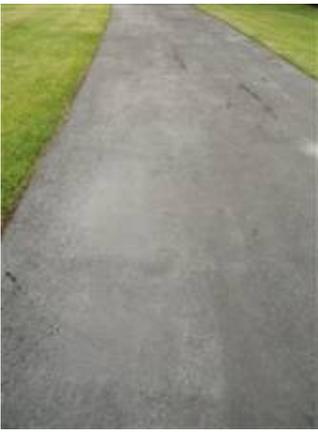
Photo 3

10) *Maintain* - Recommend resealing asphalt driveway periodically.

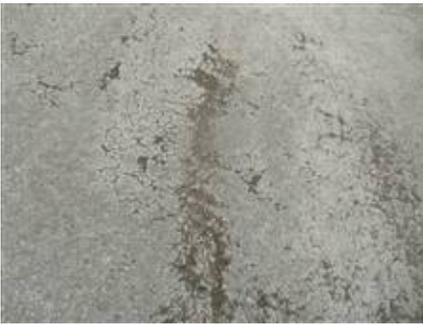
Photo 2

11) *Comment* - Minor cracks were found in the driveway. However they don't appear to be a structural concern and no trip hazards were found. No immediate action is recommended, but the client(s) may wish to have repairs made or have cracked sections replaced for aesthetic reasons.

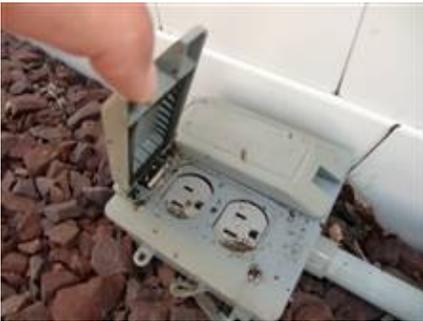
Photo 73

12) *Infestation* - Insect intrusion was found at exterior electrical receptacles. Client should inquire if owner has a current remediation contract in effect at this time and/or have a licensed exterminator evaluate and make suggestions on remediation's and/or repairs that may be needed.

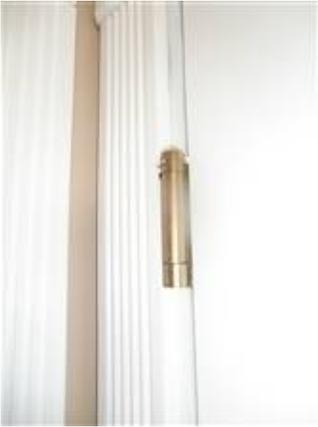
Photo 13

15) *Safety, Repair/Replace, Evaluate* - The automatic door closing device (sprung hinges, etc.) on the garage-house door needs adjustment, repair or replacing. The door doesn't close and latch easily and/or completely via the force of the automatic closing device. This door is intended to prevent vehicle fumes from entering living spaces and to slow the spread of fire from the garage to living spaces. A qualified contractor should evaluate and make repairs as necessary.

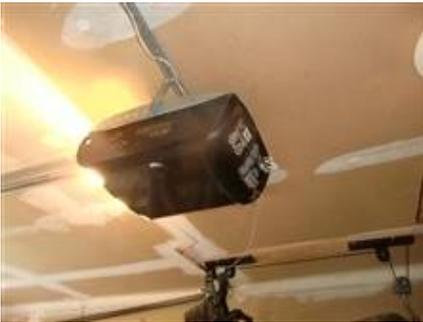
Photo 18

16) *Safety, Repair/Replace, Evaluate* - The auto-reverse mechanism on the vehicle door opener is inoperable or requires too much force to activate. This is a safety hazard, especially for small children. A qualified contractor should evaluate and repair as necessary.

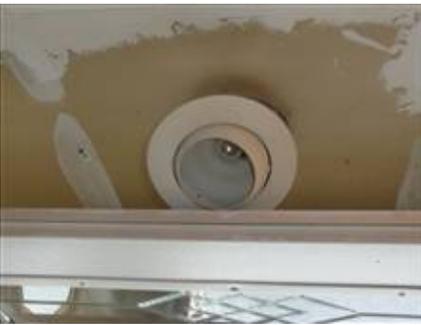
Photo 14

18) *Safety, Repair/Replace, Evaluate* - One or more light fixtures are loose or installed in a substandard way. A qualified contractor or electrician should evaluate and make repairs as necessary so light fixtures are securely mounted and installed in accordance with the manufacturer's installation instructions.

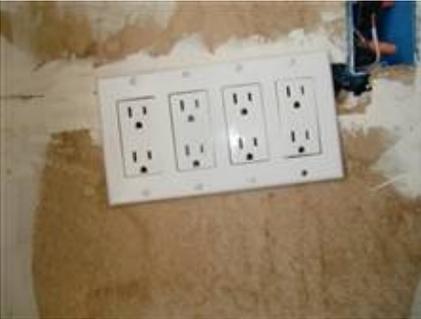
Photo 81

19) *Safety, Repair/Replace, Evaluate* - One or more garage electric receptacles appear to have no ground fault circuit interrupter (GFCI) protection. This is a safety hazard due to the risk of shock. A qualified electrician should evaluate to determine if GFCI protection exists, and if not, repairs should be made so that all garage receptacles, except for one for use with a refrigerator or freezer, have GFCI protection. For example, install GFCI receptacles or circuit breaker(s) as needed.

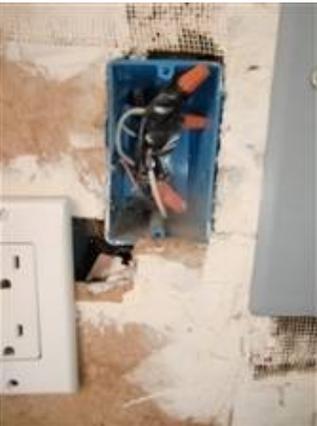
Photo 16

20) *Safety, Repair/Replace, Evaluate* - One or more sections of wiring that weren't terminated were found. This is a potential safety hazard due to the risk of shock. A qualified electrician should evaluate and repair as necessary. For example, cutting the wire to length and terminating the wire with wire nuts in a securely anchored, covered, properly sized junction box.

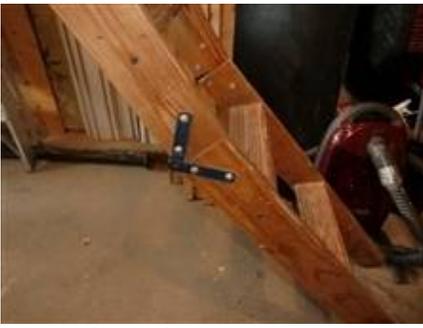
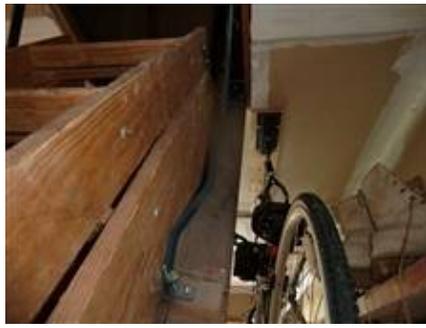
21) *Safety, Repair/Replace* - The attic pull down stairs are damaged and should be repaired and/or replaced by a qualified contractor prior to any future usage.

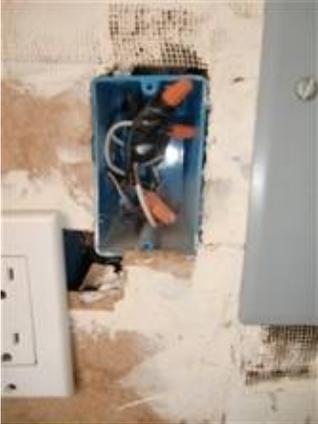
Photo 15

22) *Safety, Minor Defect* - Cover plate(s) are missing from one or more electric boxes, such as for receptacles, switches and/or junction boxes. They are intended to contain fire and prevent electric shock from exposed wires. This is a safety hazard due to the risk of fire and shock. Cover plates should be installed where missing.

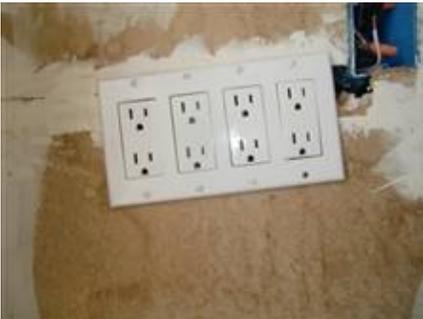
Photo 17

23) *Repair/Replace, Evaluate* - One or more electric receptacles appear to have no power. Recommend asking the property owner(s) about this. Switches may need to be operated to make some receptacles energized. If necessary, a qualified electrician should evaluate and make repairs as necessary.

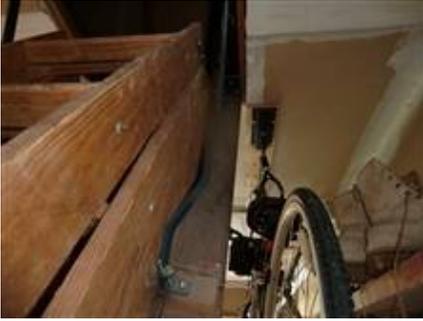
Photo 82

24) *Safety, Repair/Replace* - The attic pull down stairs are damaged and should be repaired and/or replaced by a qualified contractor prior to any future usage.

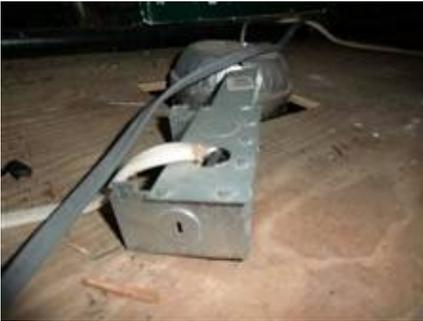
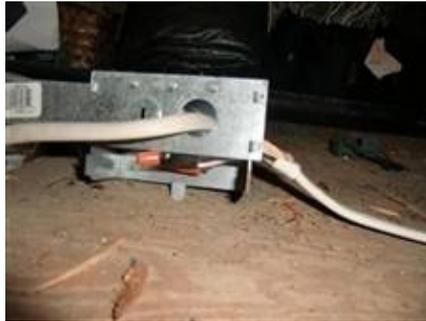
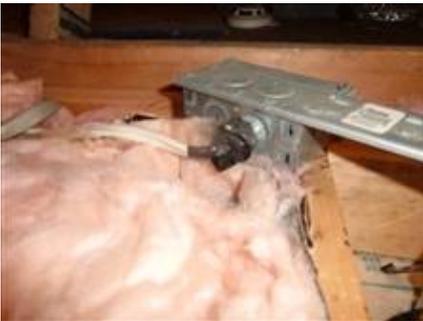
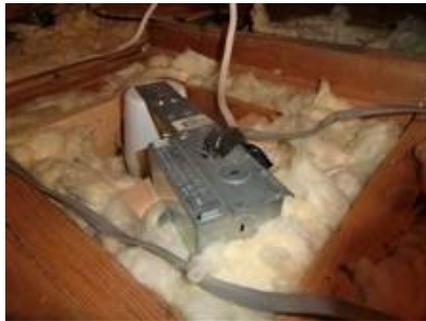
25) *Safety, Repair/Replace* - Bushings are missing from where wires enter holes in electrical boxes for recessed lighting fixtures. This is a safety hazard since the wiring insulation can be cut or abraded on the metal edge of the hole(s). A qualified electrician should install bushings where missing.

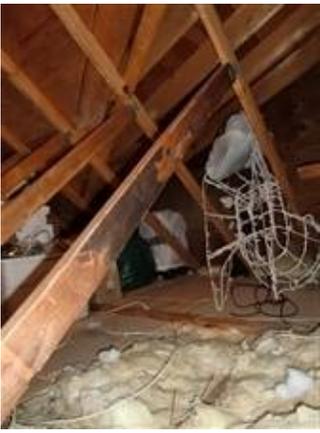
Photo 42

26) *Comment* - Some attic areas were inaccessible due to lack of permanently installed walkways, the possibility of damage to insulation, low height and/or stored items. These areas are excluded from this inspection.

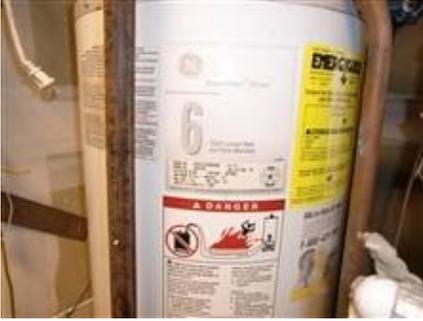
Photo 29

29) *Major Defect, Comment* - The estimated useful life for most water heaters is 8 to 12 years. This water heater appears to be at this age and may need replacing at any time. Recommend budgeting for a replacement and/or installation of an energy efficient tankless water heater in the near future.

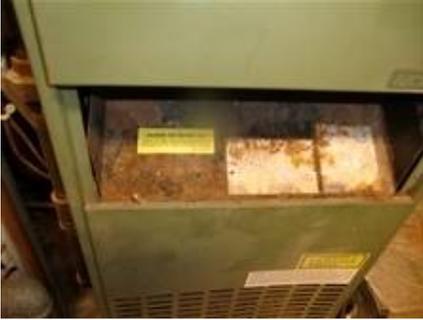
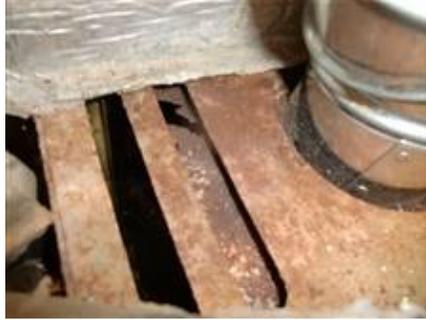
30) *Safety, Repair/Replace, Evaluate* - The heat exchanger in the gas furnace is damaged and/or deteriorated from rust, corrosion, cracking and holes. This is a safety hazard due to combustion gases entering the air supply ducts. A qualified heating and cooling contractor should evaluate and make repairs and/or replace components as necessary.

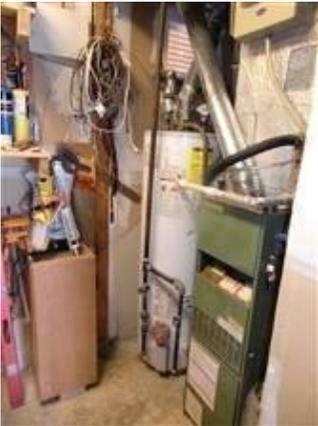
Photo 33

31) *Major Defect, Comment* - The estimated useful life for most forced air furnaces is 15 to 20 years. This furnace is older and appears to need now.

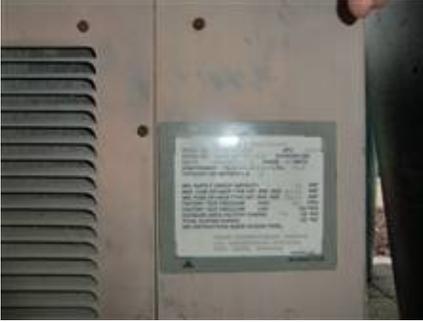
Photo 10

32) *Major Defect, Comment* - The estimated useful life for air conditioning compressors is 8 to 15 years. This unit has exceeded this age and may need replacing at any time. Recommend budgeting for a replacement in the near future.

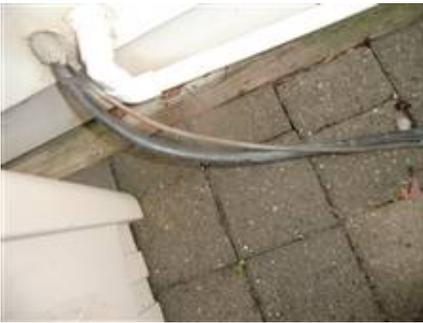
Photo 12

33) *Repair/Replace* - Insulation for the outside condensing unit's refrigerant lines is damaged, deteriorated and/or missing in one or more areas. This may result in reduced efficiency and increased energy costs. A qualified heating and cooling contractor should replace insulation as necessary.

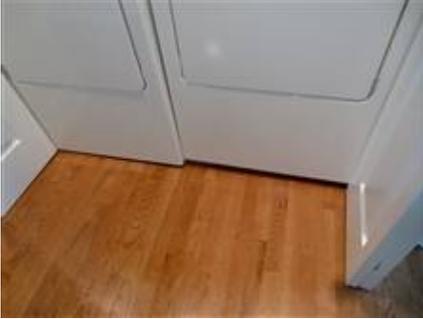
Photo 45

35) *Repair/Replace , Conducive conditions* - The washing machine is installed over a finished living space and has no catch pan or drain installed. These are not commonly installed, but they are recommended to prevent water damage to finished interior spaces below if or when the washing machine leaks, overflows or is drained. Recommend having a qualified contractor install both a catch pan and drain.

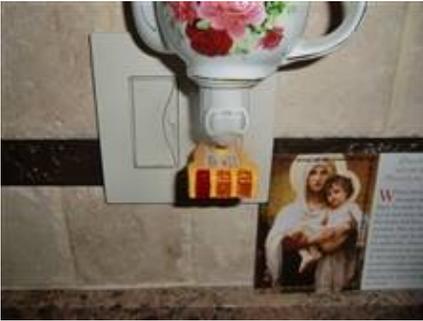
Photo 57

40) *Safety, Repair/Replace, Evaluate* - One or more open ground, three-pronged grounding type receptacles were found. This is a safety hazard due to the risk of shock. A qualified electrician should evaluate and make repairs as necessary.

Grounding type receptacles were first required in residential structures during the 1960s. Based on the age of this structure and/or the absence of 2-pronged receptacles, repairs should be made by correcting wiring circuits as necessary so all receptacles are grounded as per standard building practices. Replacement of three-pronged receptacles with 2-pronged receptacles is not an acceptable solution.

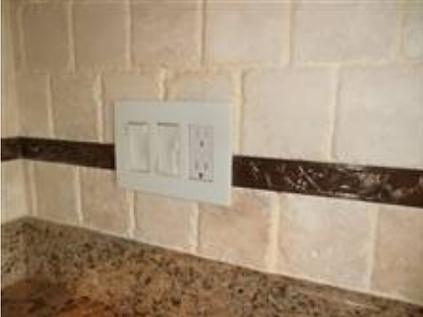
Photo 58

41) *Safety, Repair/Replace, Evaluate* - One or more electric receptacles that serve a sink area appears to have no ground fault circuit interrupter (GFCI) protection. This is a safety hazard due to the risk of shock. A qualified electrician should evaluate to determine if GFCI protection exists, and if not, repairs should be made so that all receptacles that serve kitchen/bathroom surfaces have GFCI protection. For example, install GFCI receptacles or circuit breaker(s) as needed.

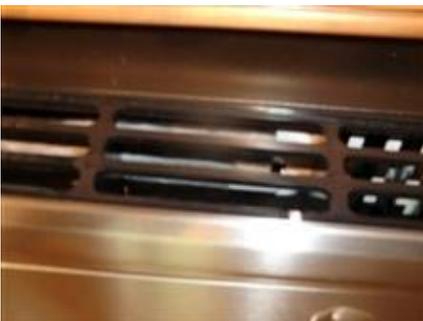
Photo 60

42) *Safety, Repair/Replace* - The microwave exhaust fan vents into the kitchen rather than outdoors. Ventilation may be inadequate and moisture may accumulate indoors. Recommend having a qualified contractor make modifications as necessary as per standard building practices so the range hood fan vents outdoors.

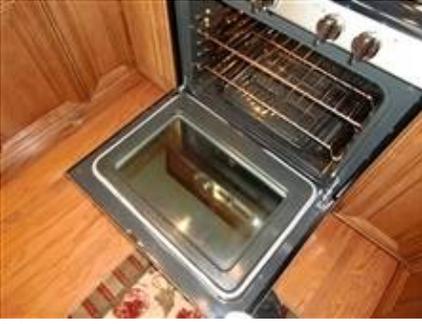
Photo 59

43) *Safety, Repair/Replace* - The range can tip forward, and no anti-tip bracket appears to be installed. This is a safety hazard since the range may tip forward when weight is applied to the open door, such as when a small child climbs on it, or if heavy objects are dropped on it. Anti-tip brackets have been sold with all free standing ranges

since 1985. An anti-tip bracket should be installed to eliminate this safety hazard.

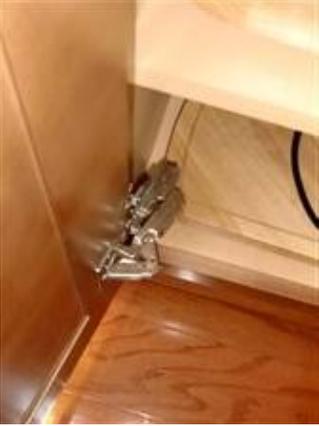
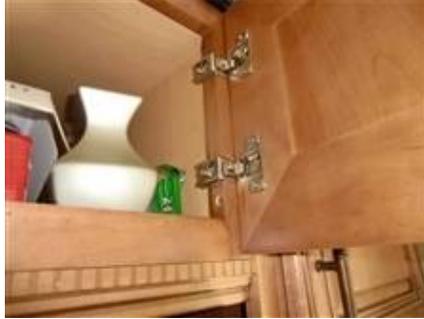
44) *Repair/Replace* - Hardware such as hinges, latches or pulls are loose on one or more cabinets. Repairs should be made and/or hardware should be replaced as necessary, and by a qualified contractor if necessary.

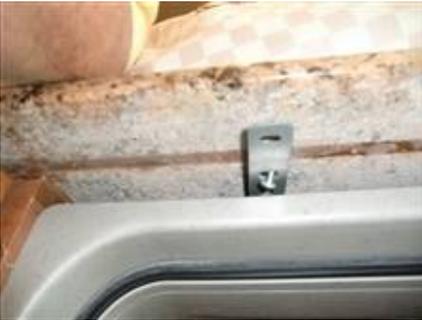
Photo 69

45) *Repair/Replace* - The bracket that attaches the dishwasher to the underside of the countertop is loose or installed in a substandard way. Repairs should be made as necessary, such as installing or reinstalling the bracket, and by a qualified contractor if necessary.

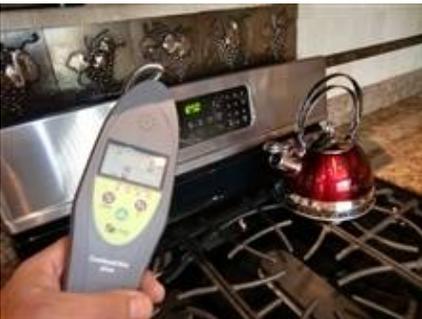
Photo 34

46) *Comment* - Evidence of gas leaks were found in living area. This is a safety hazard due to the risk of explosion and/or carbon monoxide exposure. A qualified contractor and/or the gas utility company should evaluate and make repairs as soon as possible.

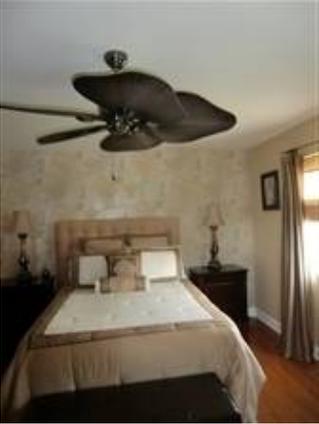
Photo 54

49) *Safety, Repair/Replace, Evaluate* - One or more ceiling fans are installed less than seven feet from the floor below. This is a safety hazard. A qualified contractor should evaluate and repair as necessary. For example, remove fans, or move them as necessary to maintain a seven foot clearance below. Ideally ceiling fans should be installed at least eight to nine feet above the floor for optimal air flow.

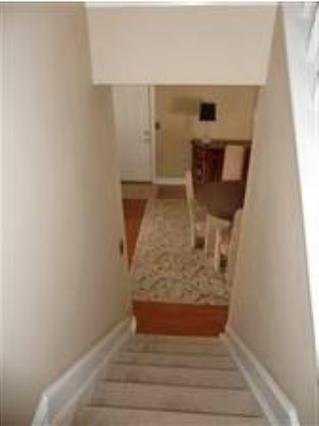
Photo 53

50) *Safety, Repair/Replace* - One or more stairs with more than two risers have no handrail installed. This is a safety hazard. A qualified contractor should install graspable handrails that your hand can completely encircle at stairs where missing, and as per standard building practices.

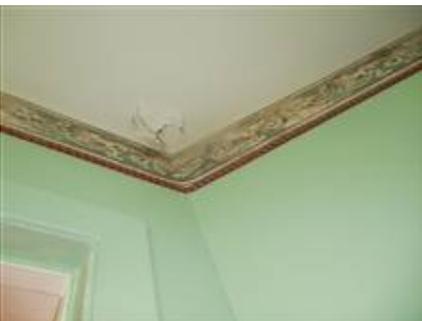
Photo 48

51) *Comment* - Minor damage was found in ceilings in one or more areas. They do not appear to be a structural concern, but the client(s) may wish to repair these for aesthetic reasons.

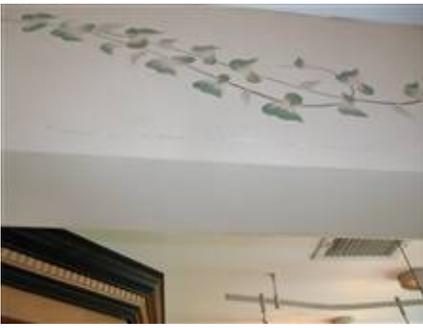
Photo 66

52) *Comment* - Minor cracks were found in walls in one or more areas. They do not appear to be a structural concern, but the client(s) may wish to repair these for aesthetic reasons.
